**COLBERT COUNTY
SCHOOLS**

Facility Assessment Report

Prepared by:
Volkert, Inc.

September 30, 2022

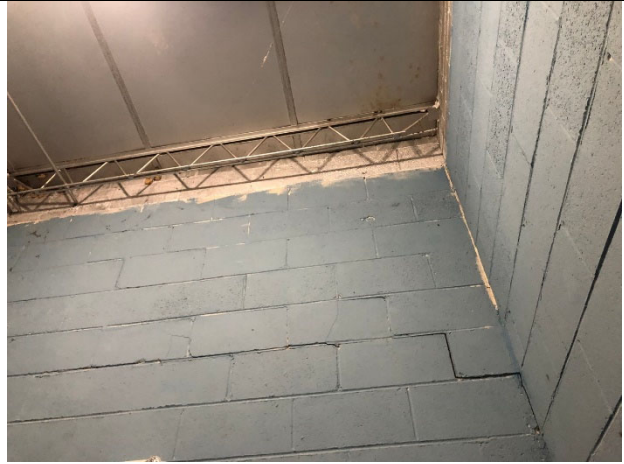
View of settlement at Auditorium.

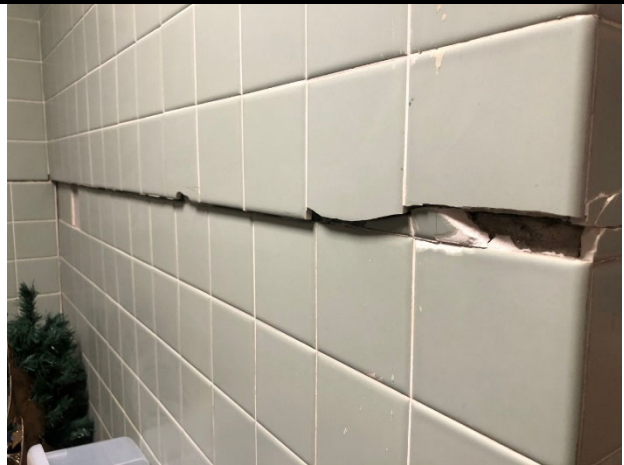
View of settlement at Auditorium.

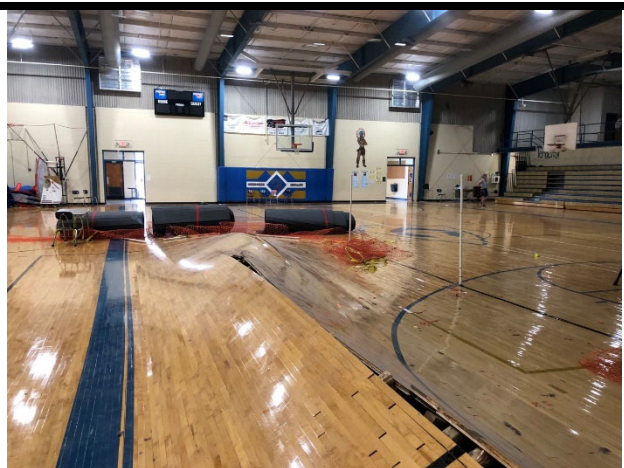
VCT flooring in the Lobby was observed to be in overall fair condition. Sealed concrete flooring on the mezzanine level was observed to be in overall fair condition. Athletic wood flooring in the gymnasium was observed to be in overall poor condition, with major damage observed due to apparent water infiltration. CMU and metal panel walls were observed to be in overall good to fair condition. 2'x2' acoustical ceiling tiles were observed with 2'x4' lay-in fluorescent lighting fixtures in the Lobby. An exposed structure ceiling was observed with 2'x4' suspended fluorescent lighting fixtures in the gymnasium. These ceilings and lighting fixtures appeared to be in overall good to fair condition. Wood flush doors with hollow-metal frames were observed to be in overall fair condition. Door hardware appeared to be in overall poor condition. Concessions area has custom wood cabinets with a plastic laminate finish that appeared to be in overall fair to poor condition. Both commercial and residential food service equipment was observed in this area. Gymnasium equipment consisted of two retractable main basketball goals with acrylic backboards and four retractable side basketball goals with fiberglass backboards. This equipment appeared to be in overall fair condition. 9-tier manually telescoping bleachers with plastic seating for approximately 850 spectators were observed to be in overall fair condition. A sound system consisted of a suspended spherical speaker and appeared to be in fair condition. There is a wheelchair lift system near the main entrance of the school to transition from that elevation to the gymnasium elevation. It appears that the gymnasium is ADA compliant. Apparent water infiltration through the building envelope has severely damaged the athletic wood flooring on the west side. There have been 2 new pad-mounted HVAC mechanical units installed just outside the west wall, and it is suspected that a negative pressure environment currently exists.

View of Athletic Flooring Damage.

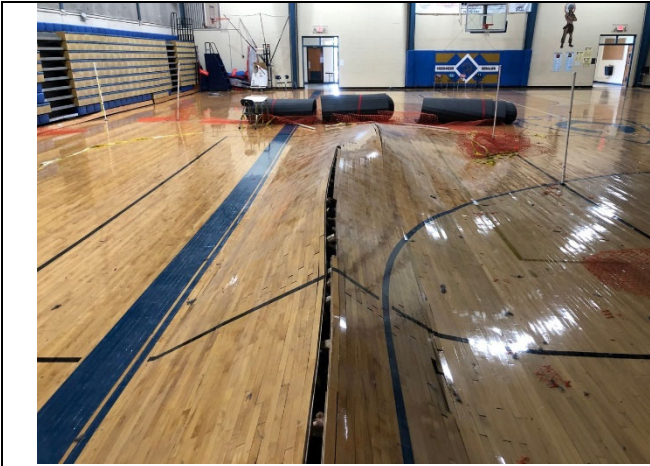
View of Athletic Flooring Damage.

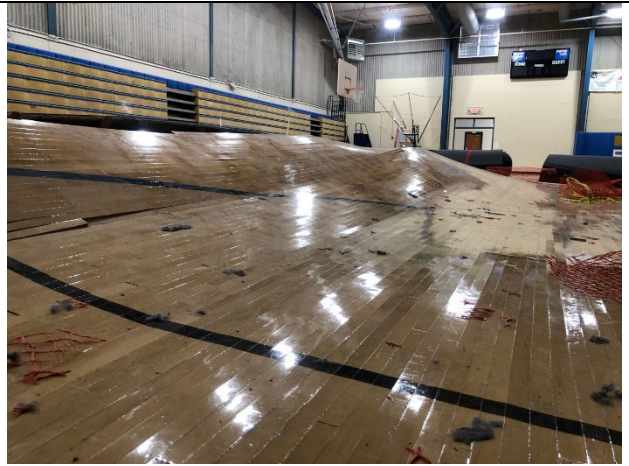
View of Athletic Flooring Damage.
