11-1-2022

Colbert County Schools  
425 Hwy 72 West, PO Box 538  
Tuscumbia, AL 35674

Reference: Structural Assessment Report  
Cherokee High School  
Cherokee, Alabama  
Structural Design Group Project Number: 22-216

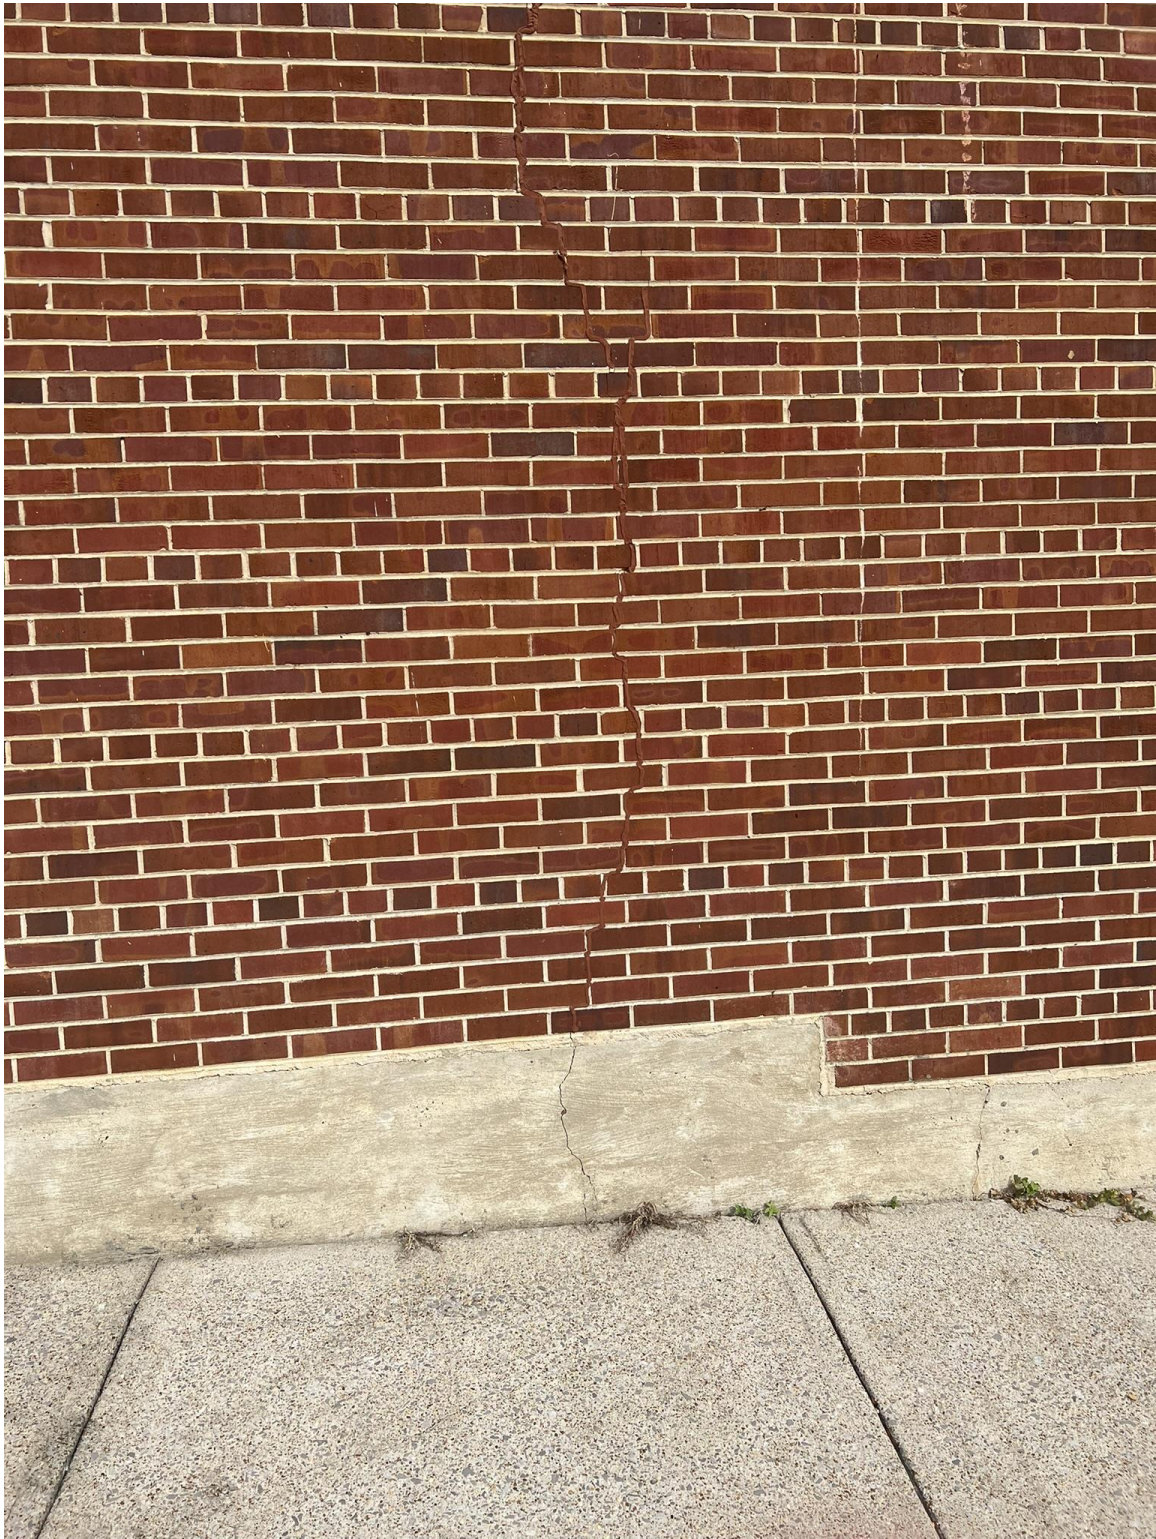
- 1) The Brick veneer and concrete base on the outside of the building has both significant and hairline cracking. Most all the cracking is due to long fields of walls with no control joints installed for movement and crack relief. The wall has cracked in several locations with joints wide enough to allow water into the building. Even though the brick veneer did not appear to be structurally compromised, water intrusion into the building can allow further deterioration and a failure of the veneer. To allow proper movement of the brick wall I would recommend the installation of vertical control joints in the brick veneer and repair of the existing cracks in the bricks and mortar joints. Cracking in the concrete base will also need repair to prevent further damage to the wall. Cracks larger than hairline in width should be routed to 1/4" depth and a sealant installed over the joint.

Cracking in the brick veneer and concrete base

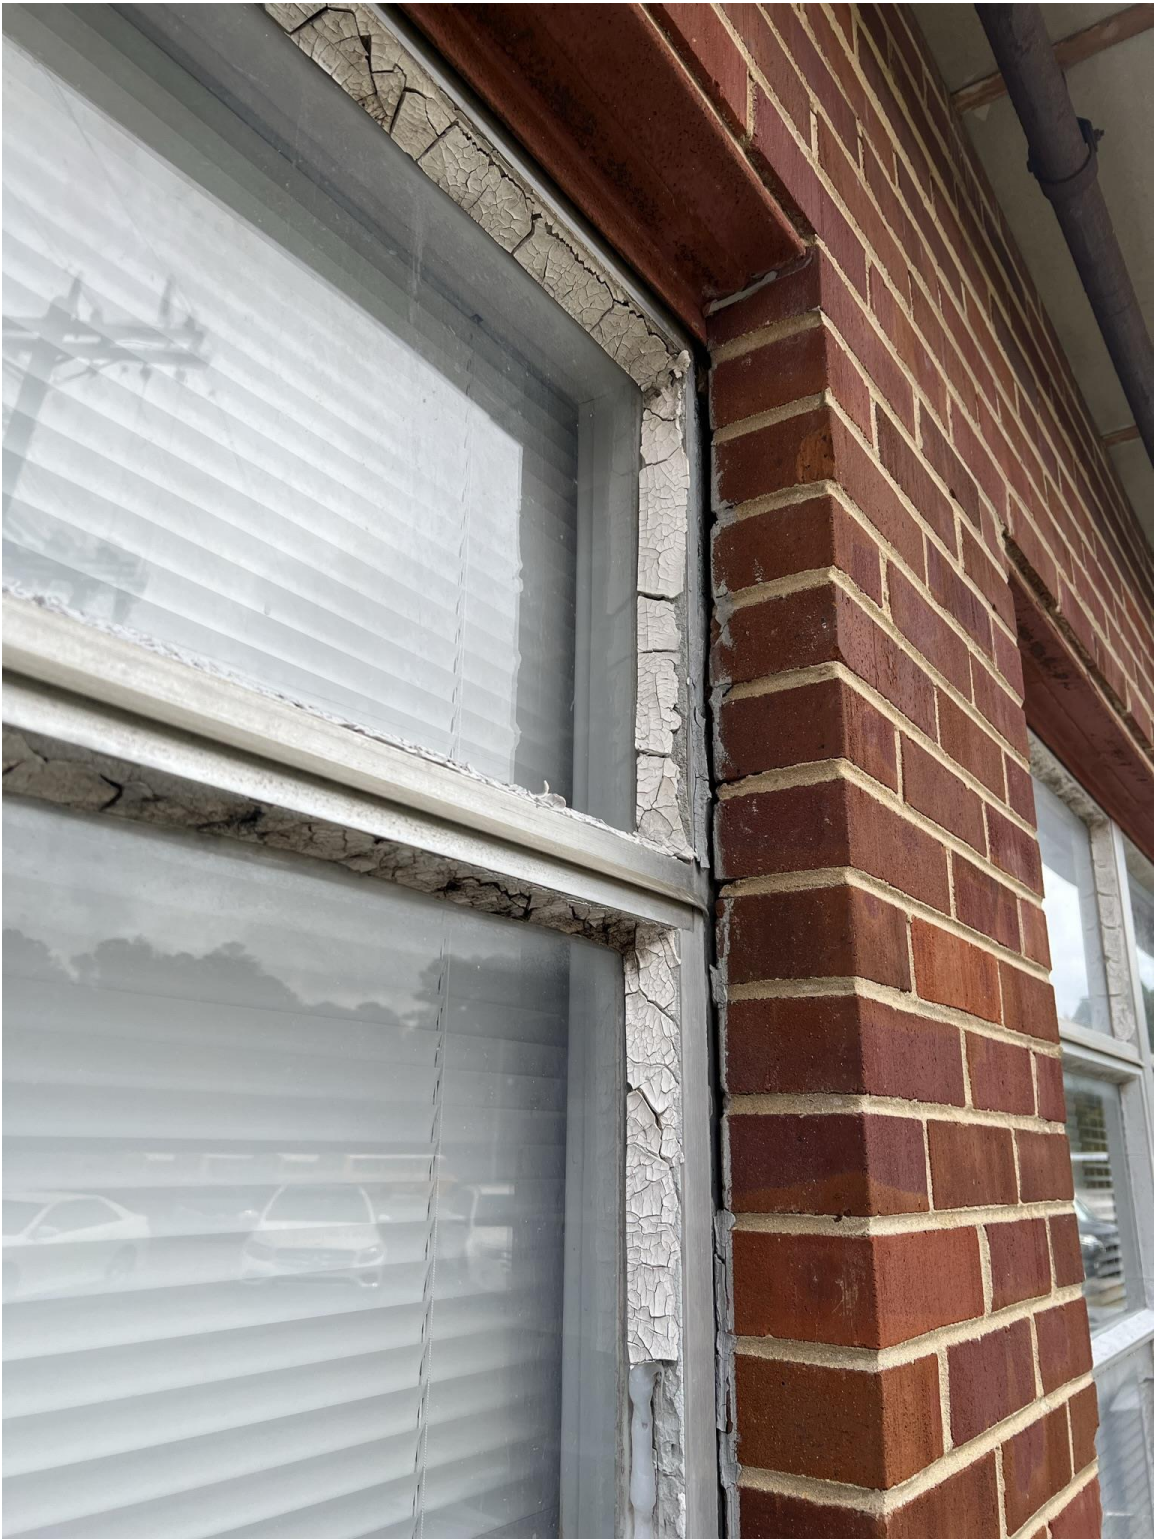
- 2) On the older Classroom wings several of the windows appear to have become dislodged from the window opening. These are large window openings and, if not properly anchored at the jambs, may constitute a structural hazard. Possible replacement of the windows should be considered and at a minimum the dislodged windows need to be repaired.

Windows separated at head and jambs

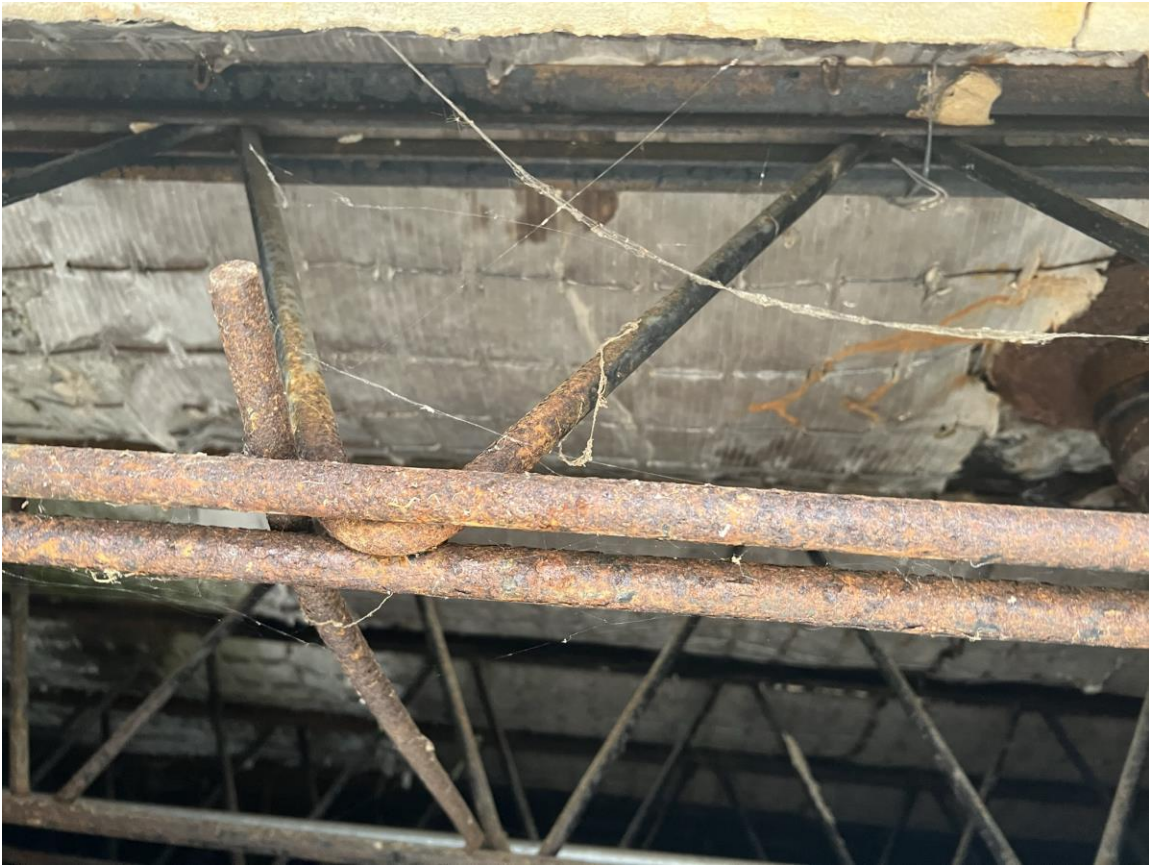
- 3) The Kitchen floor consists of steel open web bar joists and concrete fill over a low crawl space. The joist could only be observed thru an exterior opening. The joists closest to the opening was rusting. The observable joists did not exhibit rust to the extent of loss of section, but it is recommended this floor be thoroughly investigated for damage and existing rusted joists be cleaned, primed, and painted to prevent further damage.

Rusting of bar joist floor supports at the Kitchen

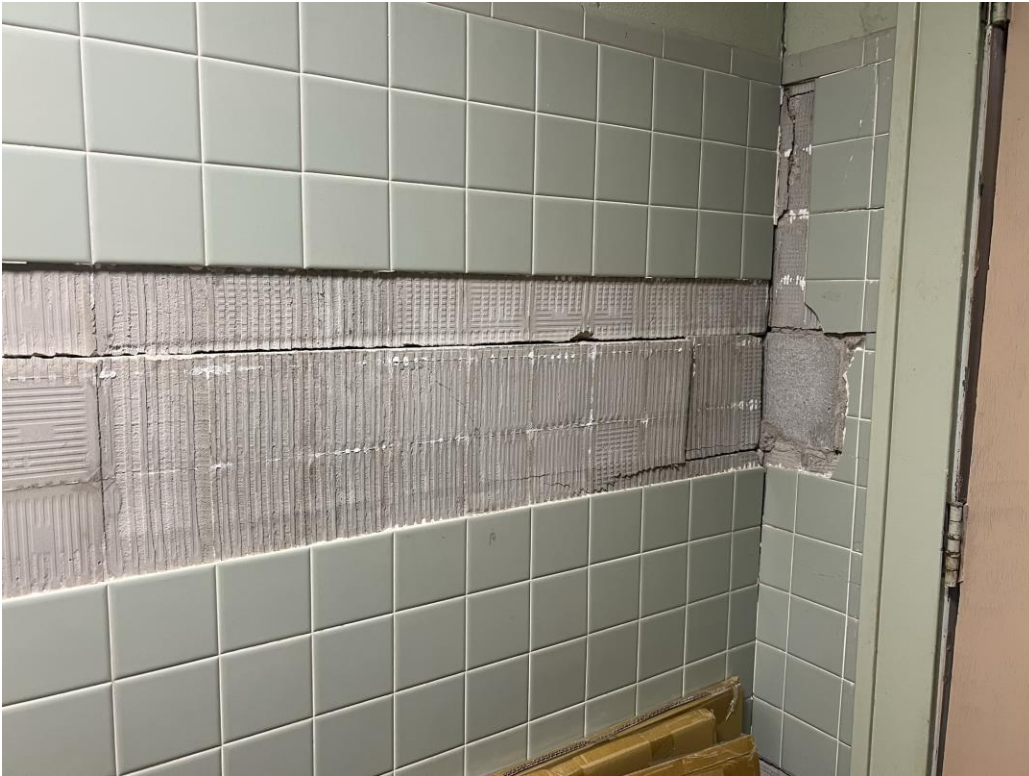
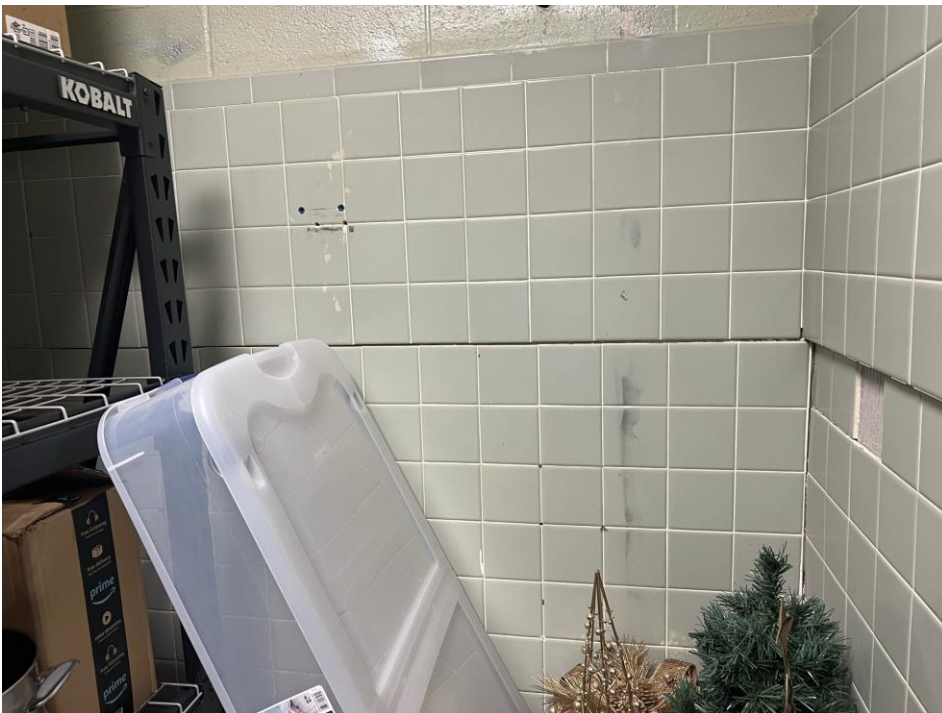
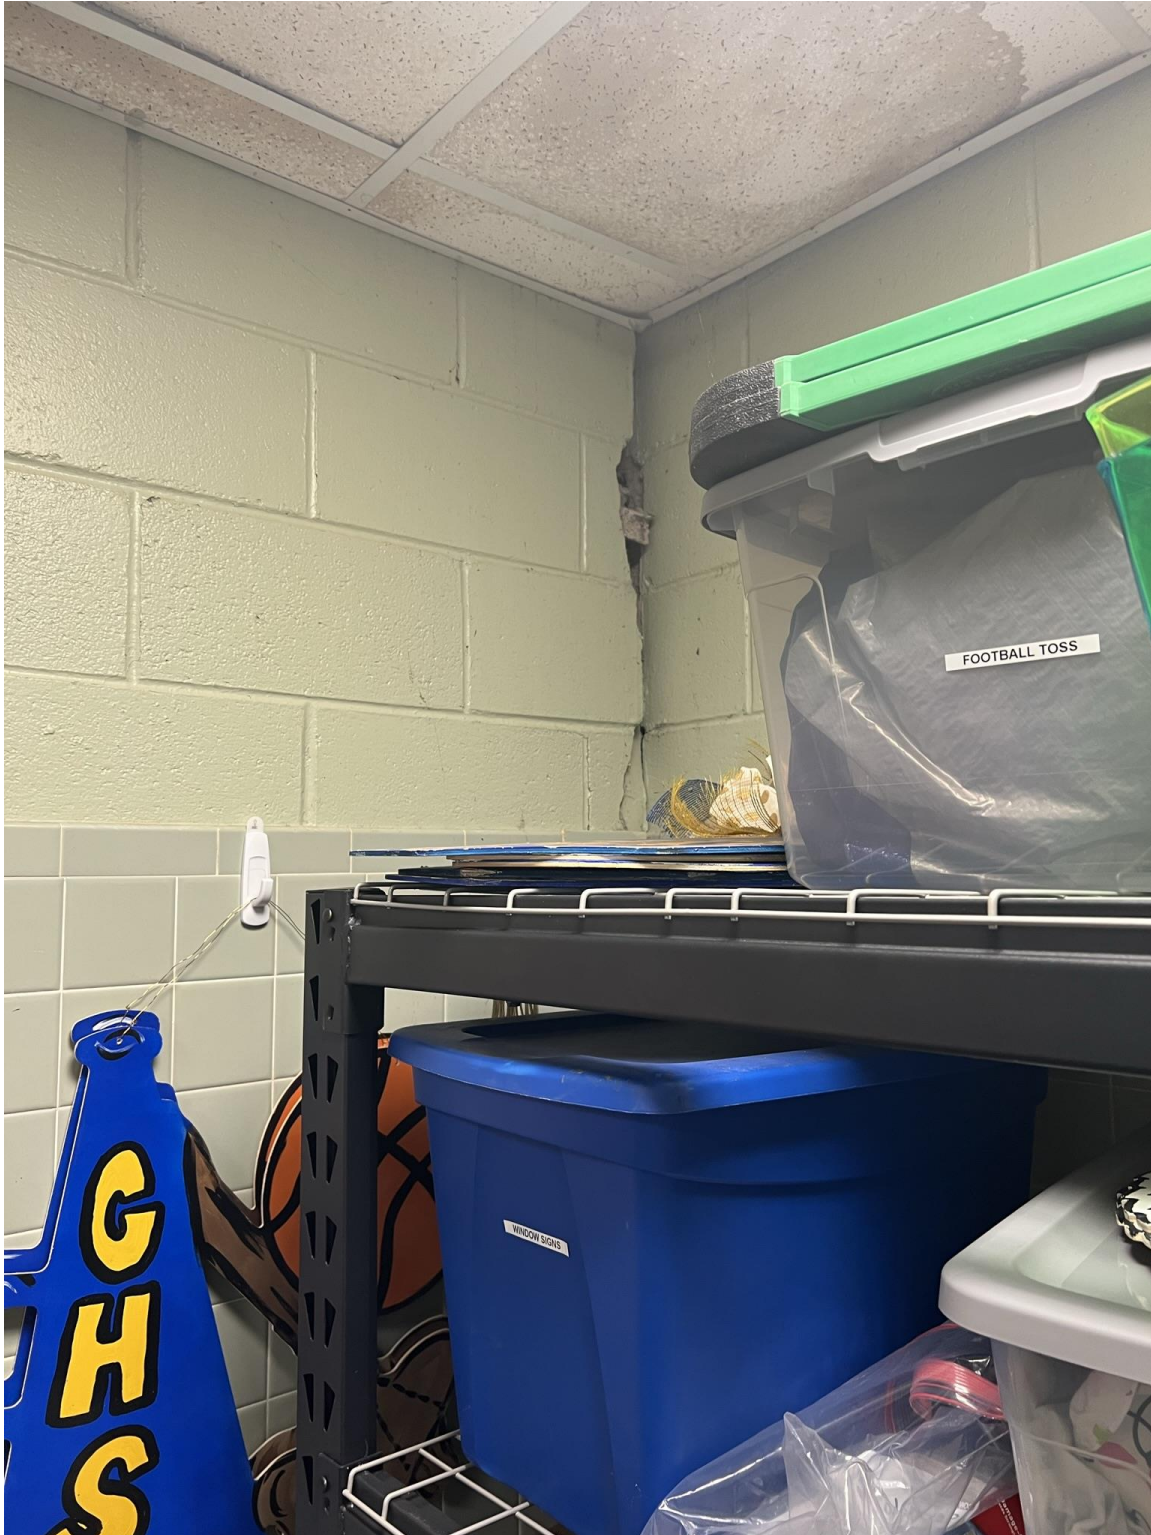
- 4) The Storage area to the right (facing the Auditorium Entrance) at the side entrance to the building has two walls with severe cracking. It appears these walls are bearing on the concrete slab on grade and this slab has settled allowing the wall to settle and crack. These two walls will need to be removed, any voids below the slab on grade filled, and the wall rebuilt. The wall closest to the Auditorium could not be determined to be non-load bearing. Repair in this area should start with a full removal of the ceiling finishes to determine if

- walls are non-load bearing prior to wall removal. Please note that these walls are dangerous and in need of immediate repair. Additionally, in this same area, at the exterior Corridor door, the masonry wall has a substantial crack that has been filled with sealant. Given the proximity to the Storage room, and the potential void below the slab extent not being known, it would be my recommendation that the Auditorium and this exit be closed until further investigation and repairs to this area can be made.

Cracking of the walls in the Storage Room adjacent to the Auditorium

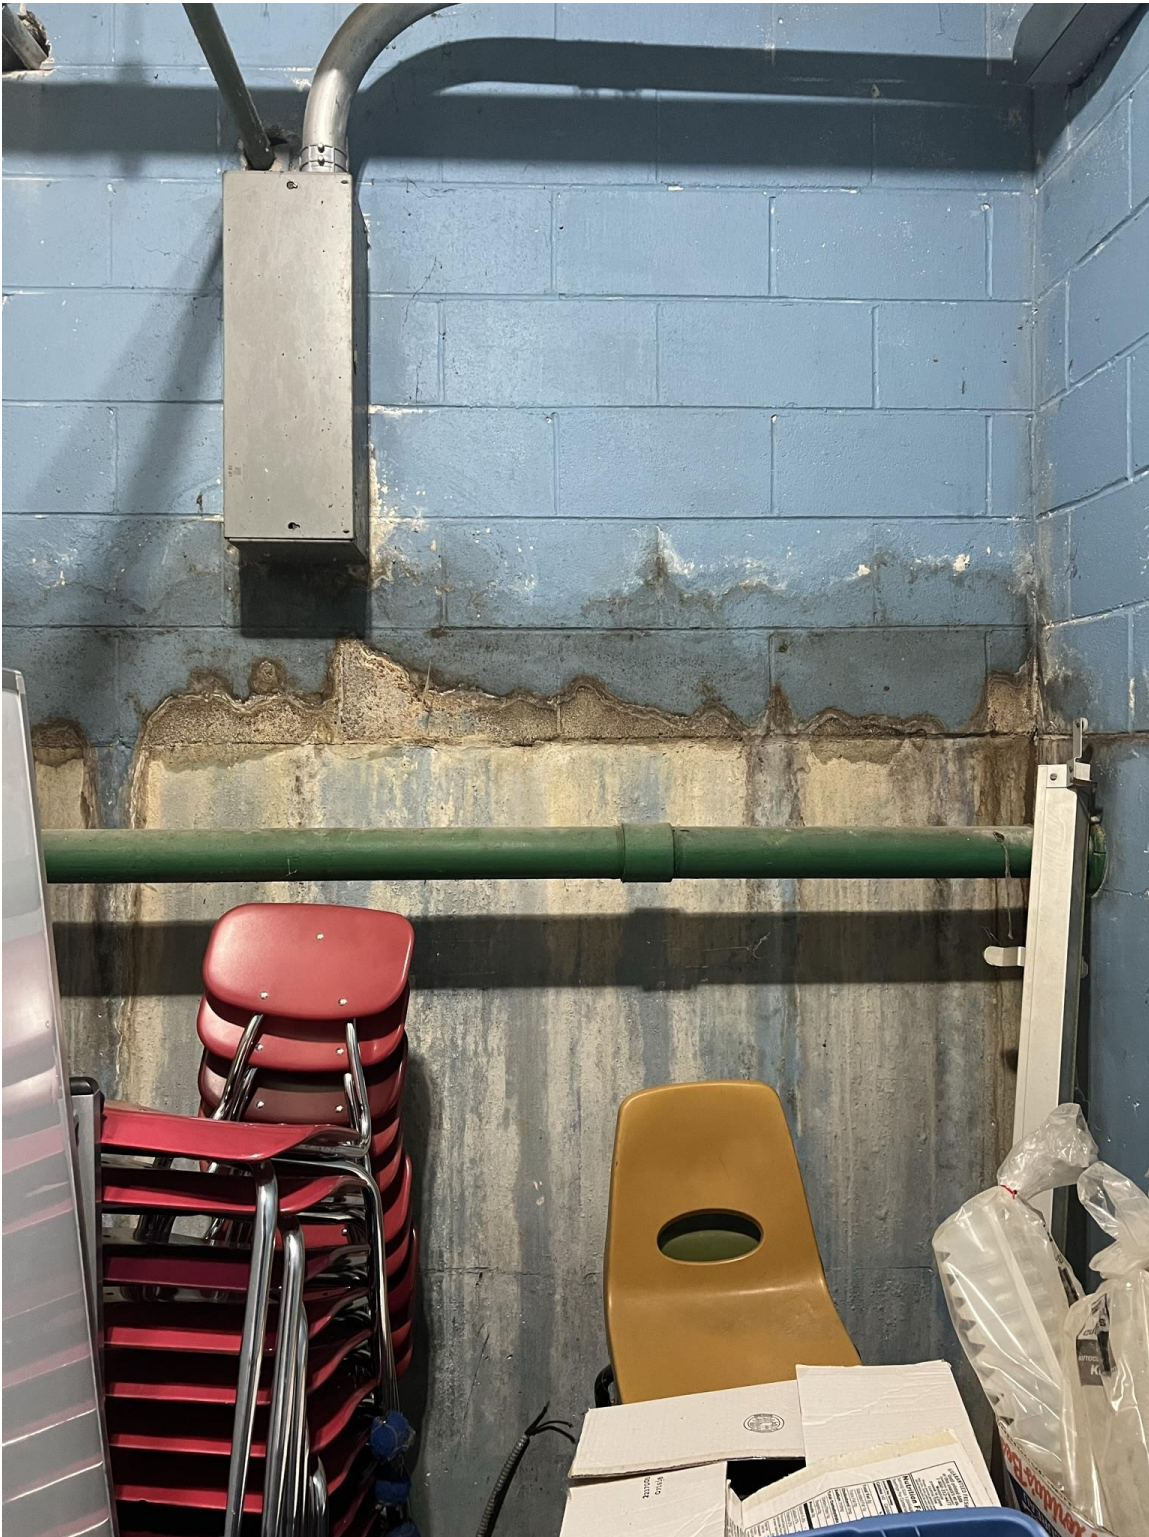
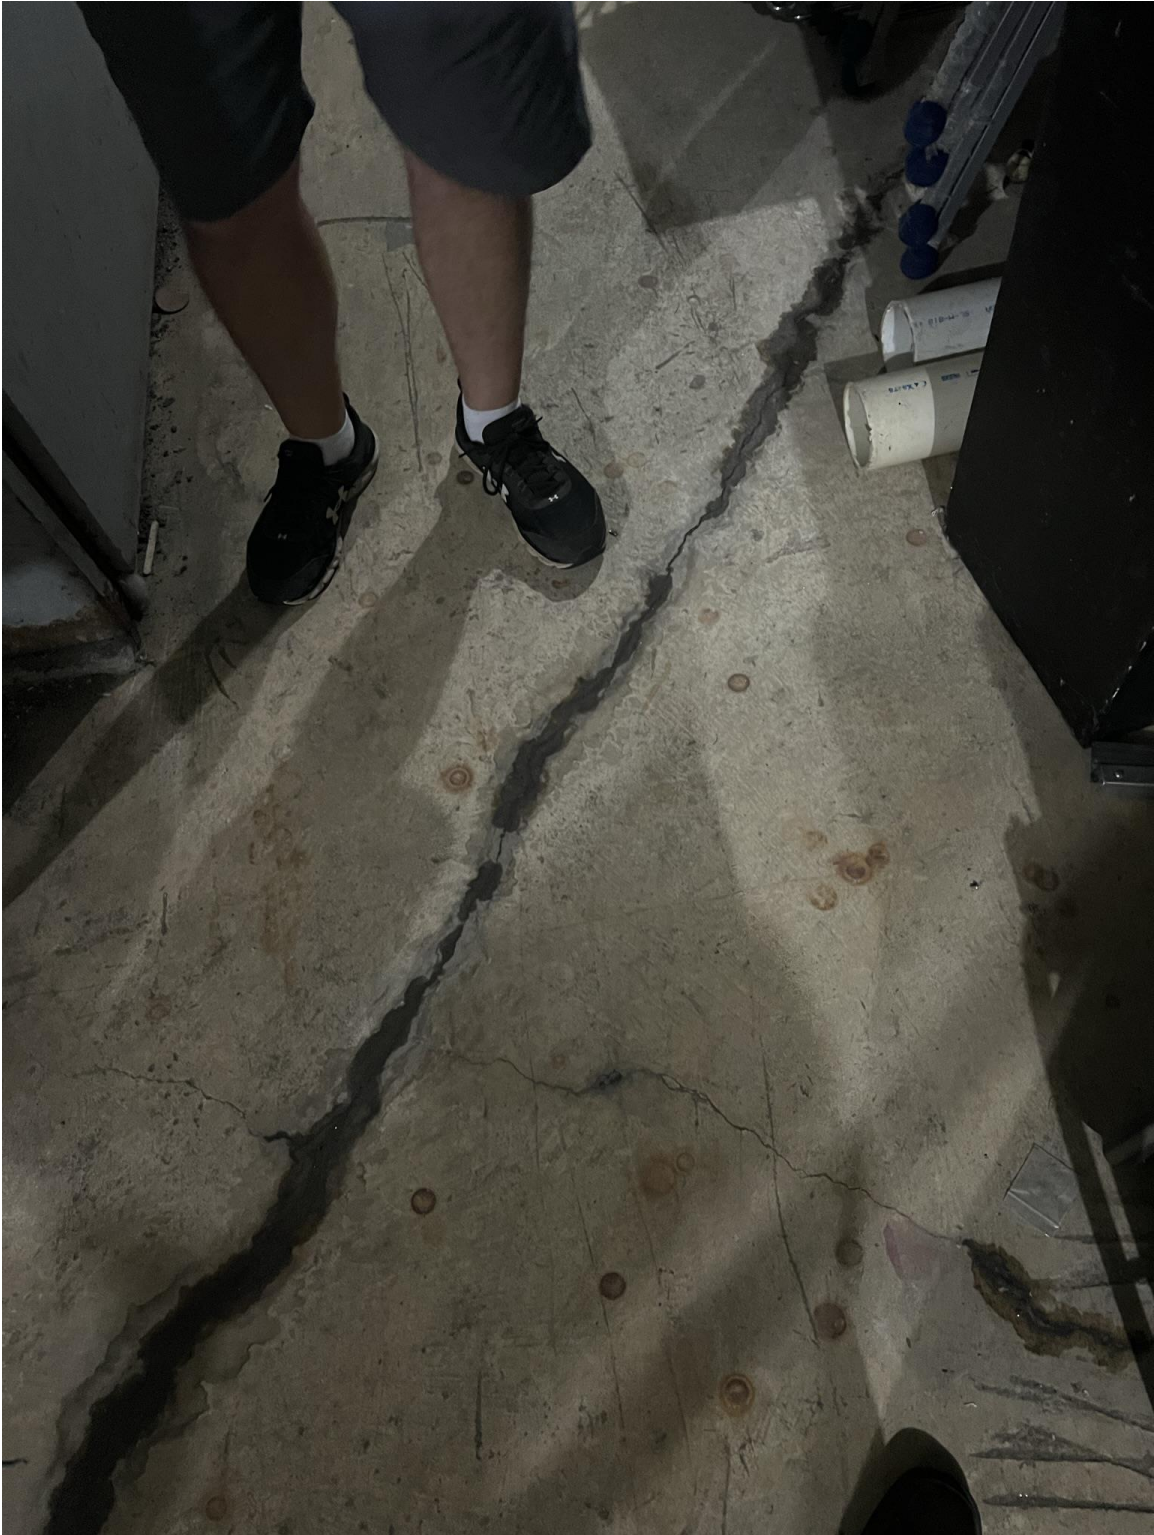
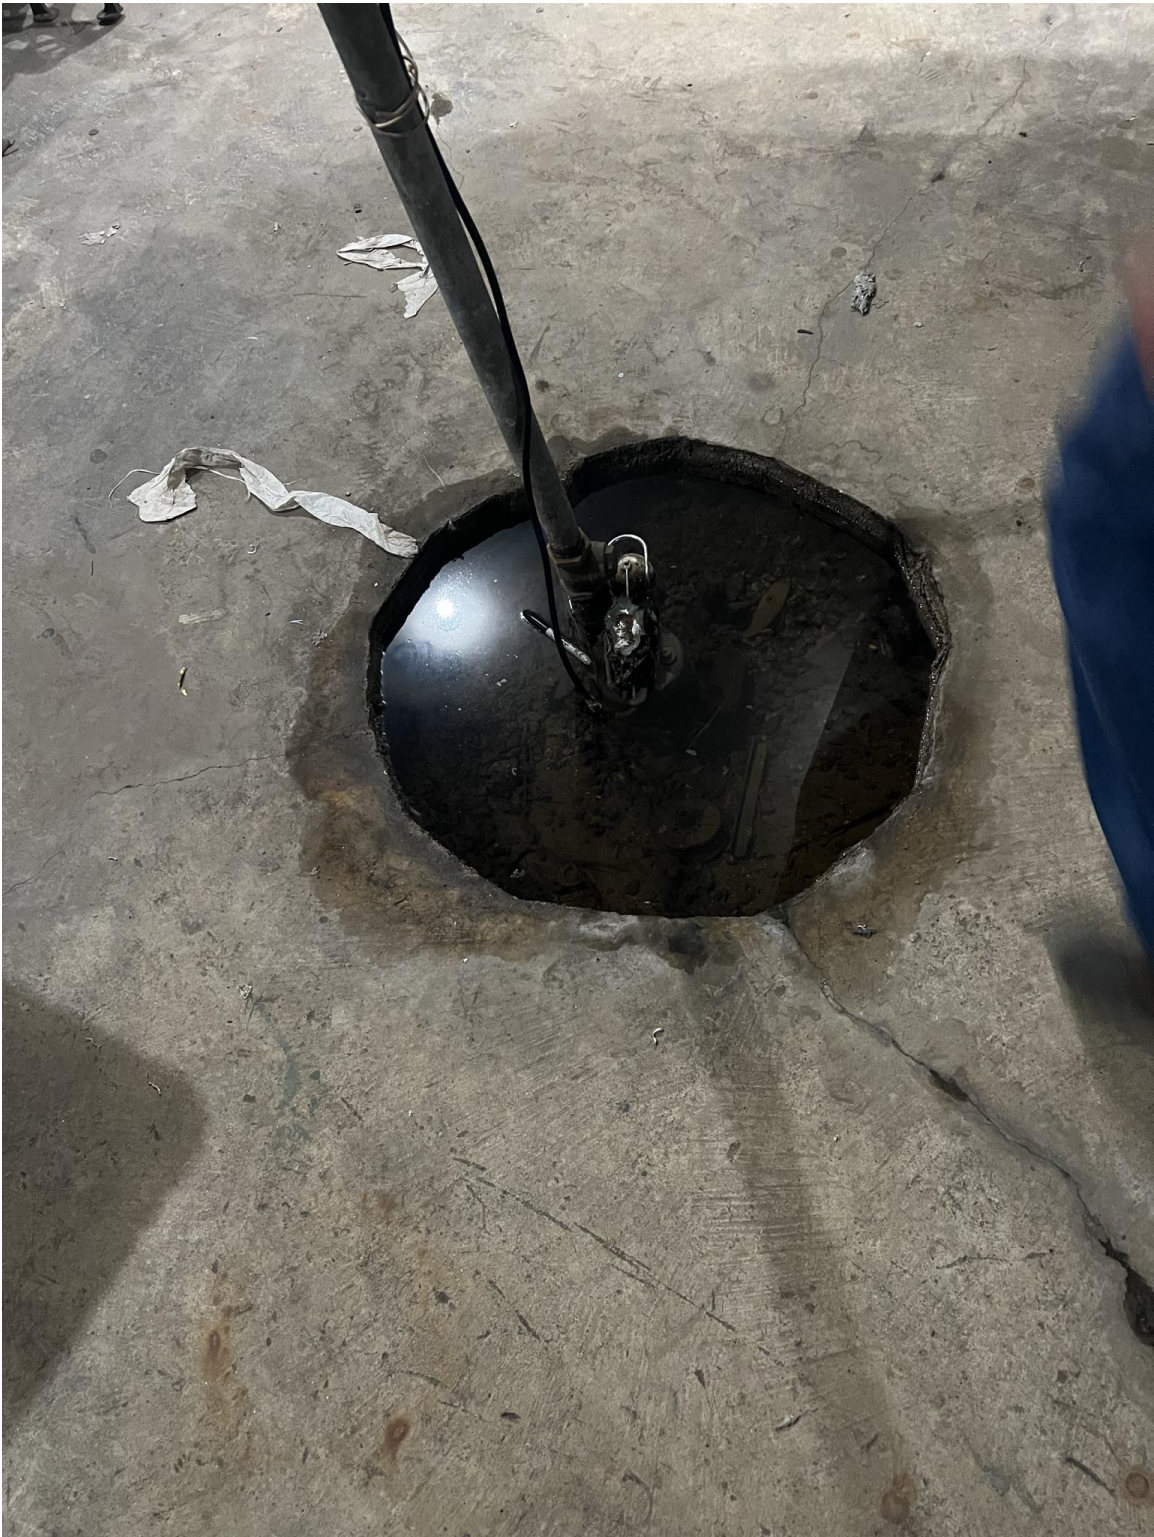
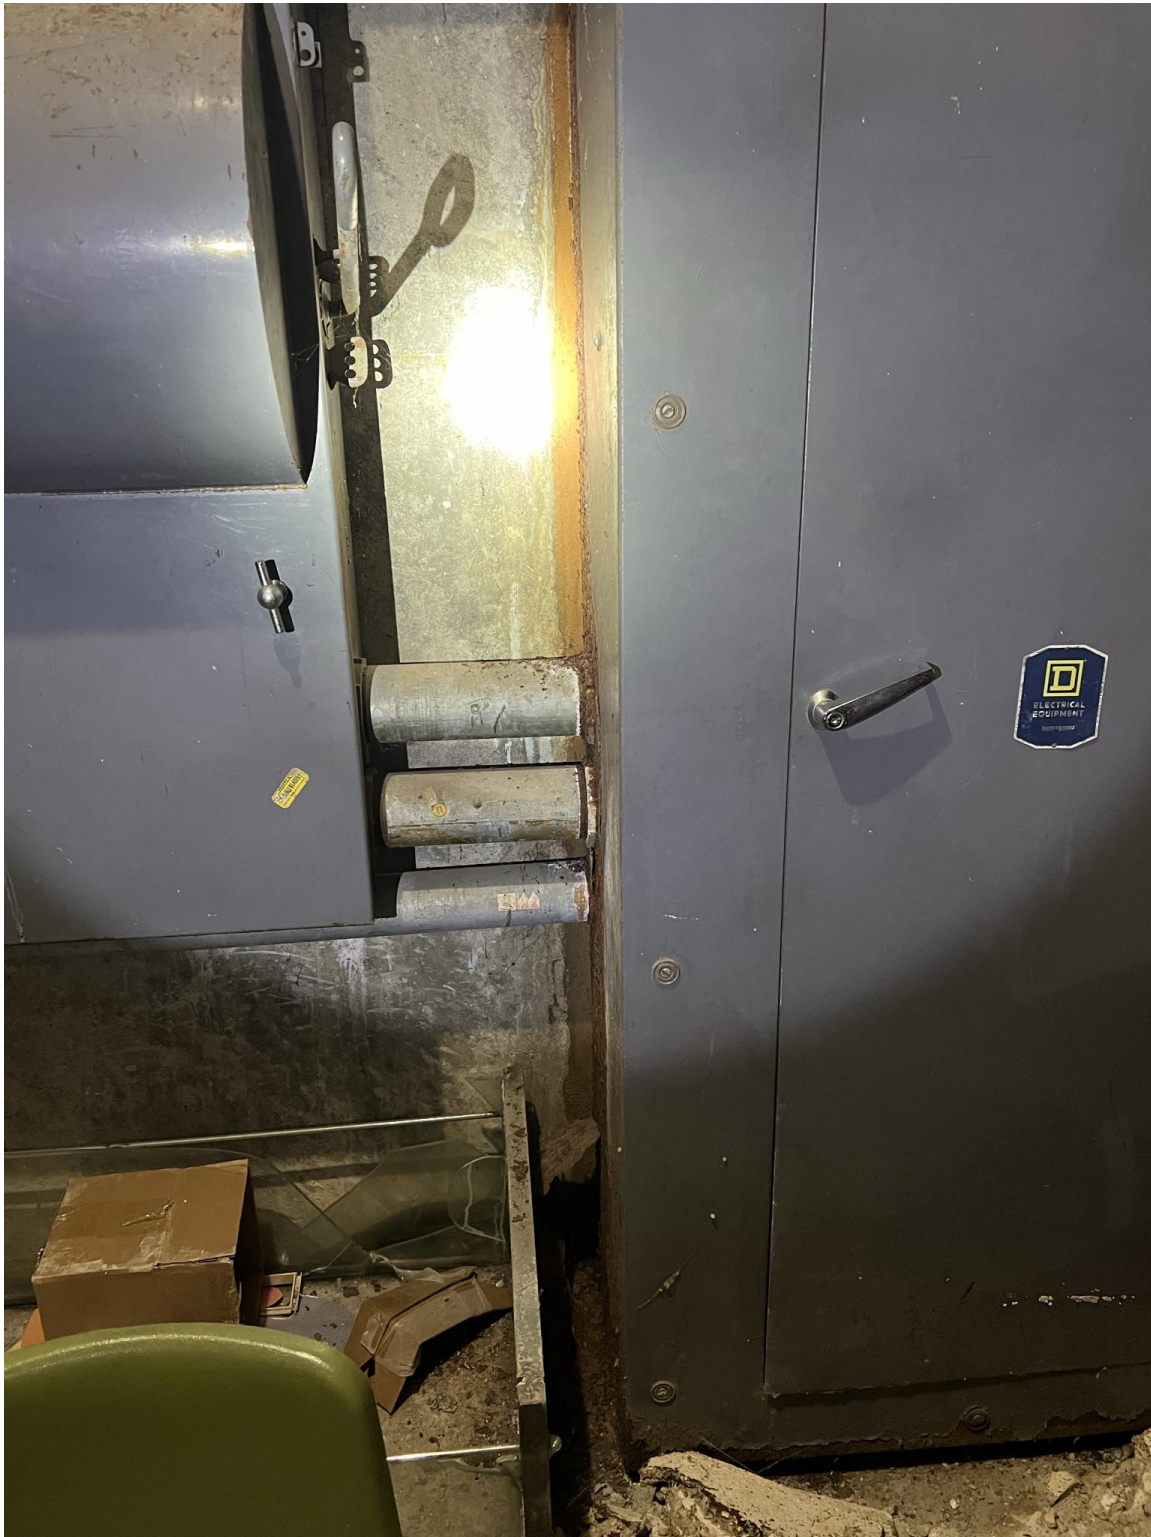
- 5) The mechanical and electrical basement area below the Auditorium Stage has water infiltration issues. Water appears to be coming thru the wall of the basement behind large electrical panels. The panels appear to be very old and have significant rusting of the electrical box on both the sides and the bottom. This water intrusion needs to be mitigated and the electrical panel observed for damage. The sump pump in this area was running and was full of water. A crack in the floor slab had water seeping up onto the slab on grade. This would indicate the presence of a hydrostatic head of water either as ground water or water built up behind the walls. Even though there are no immediate signs of structural damage the walls are not recommended to retain water.

Water intrusion into Mechanical Basement

Water seeping up thru crack in basement floor

Sump pump is full and running continuously

Water infiltration thru wall behind electrical panel

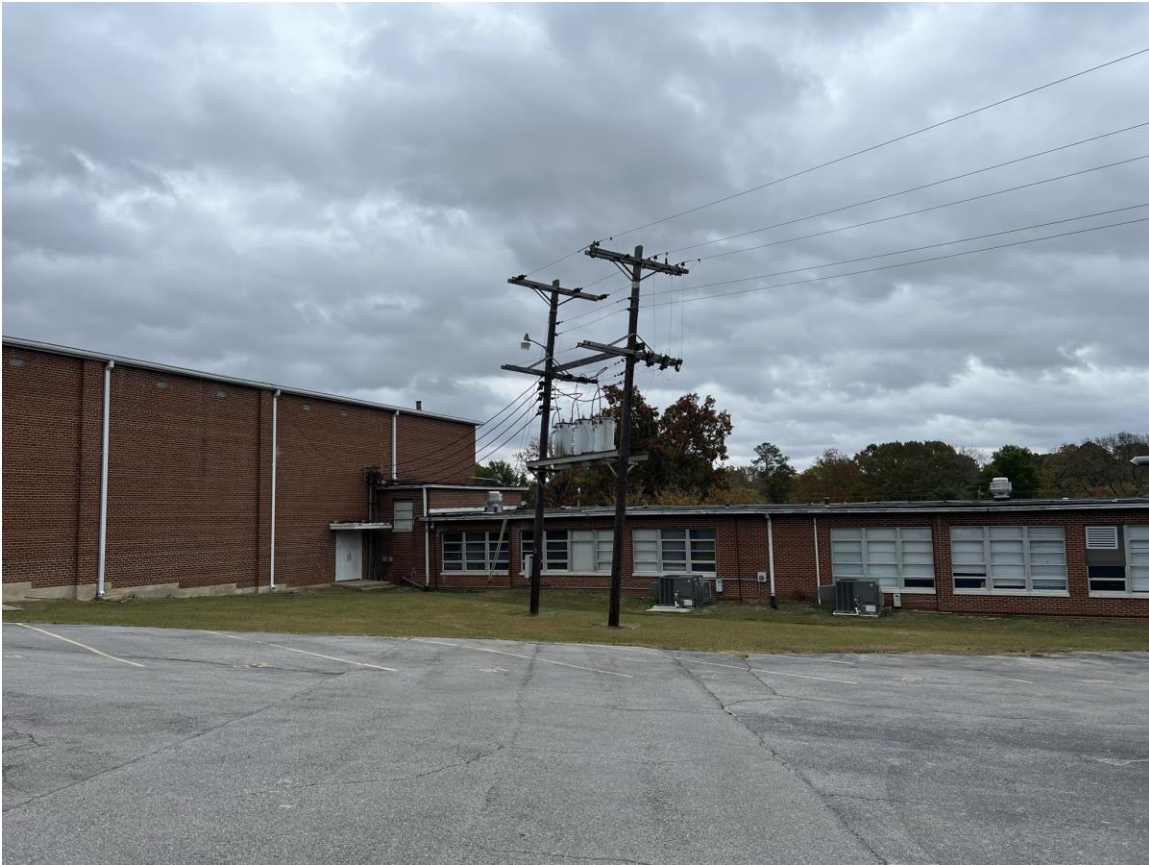
- 6) The electrical transformers outside of the Auditorium are elevated above the grade on wooden poles. These poles are leaning towards the building and appear to be in poor structural condition. The support for the transformer should be repaired.

Leaning supports of Electrical transformers

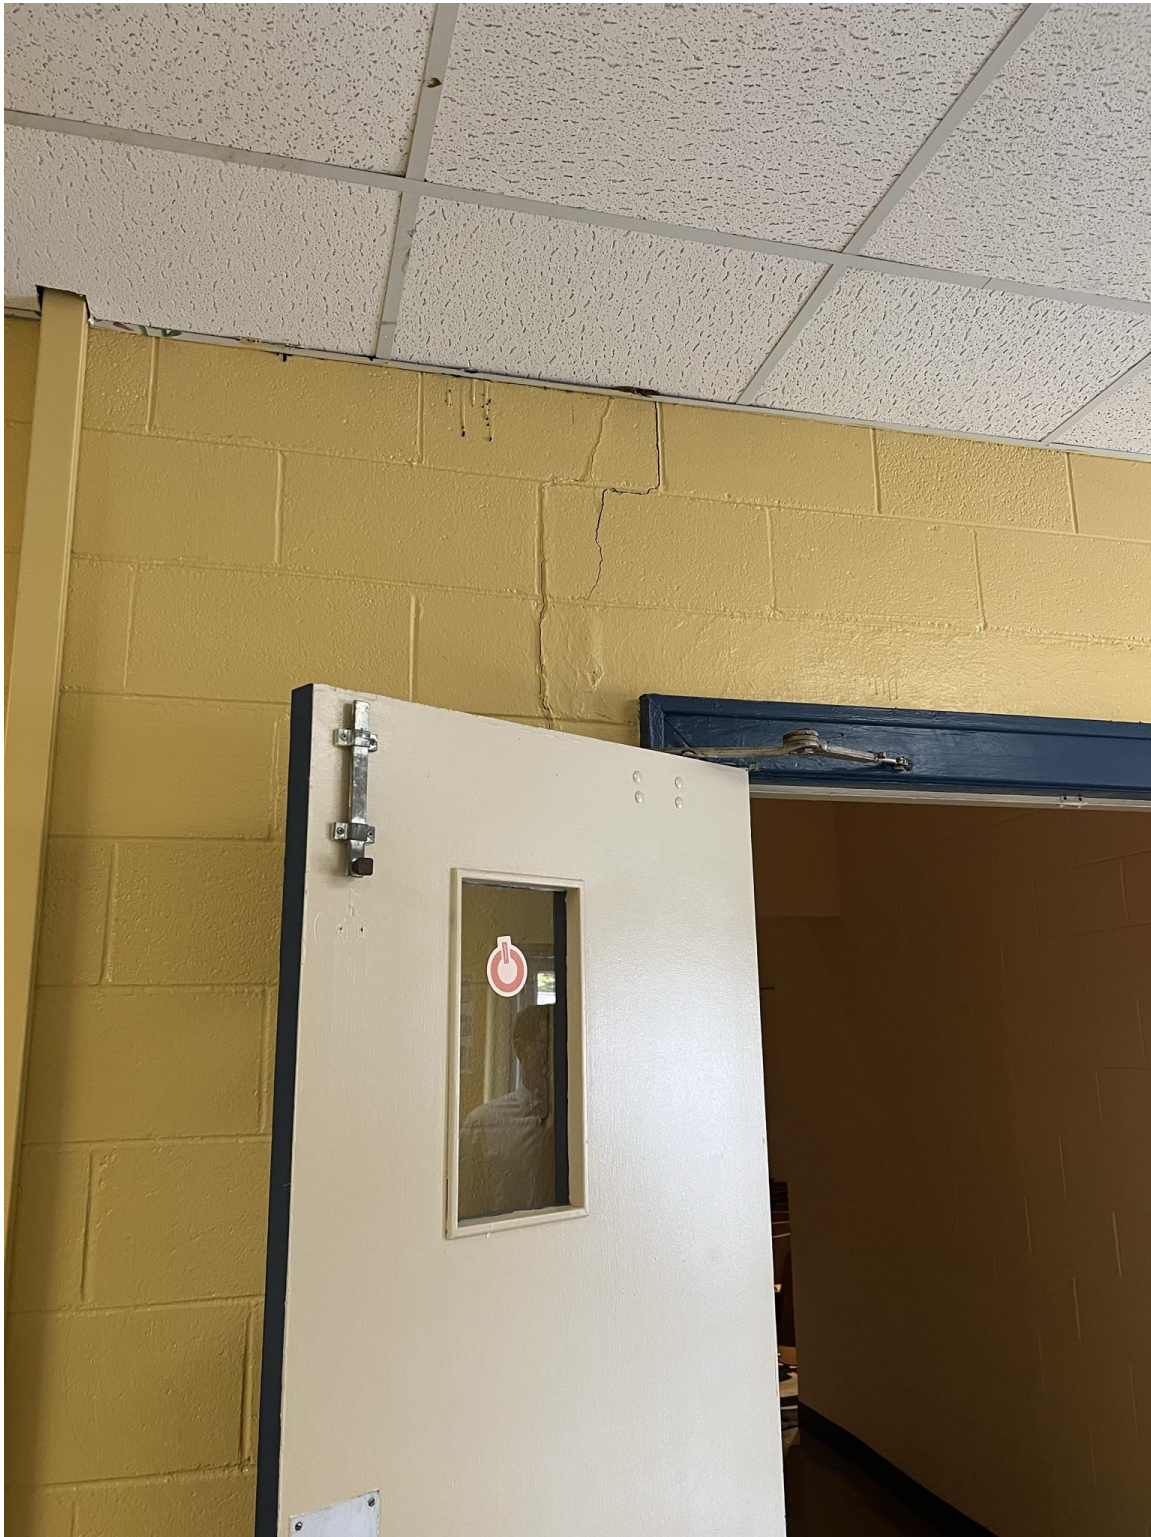
- 7) Several cracks were noted inside the building, most of which have been repaired in the past. All the cracking, except for those noted in item 4 above, appear to be shrinkage cracks due to the lack of installed control joints. Permanent repair will require the installation of vertical control joints in the block.

Cracking in interior masonry walls

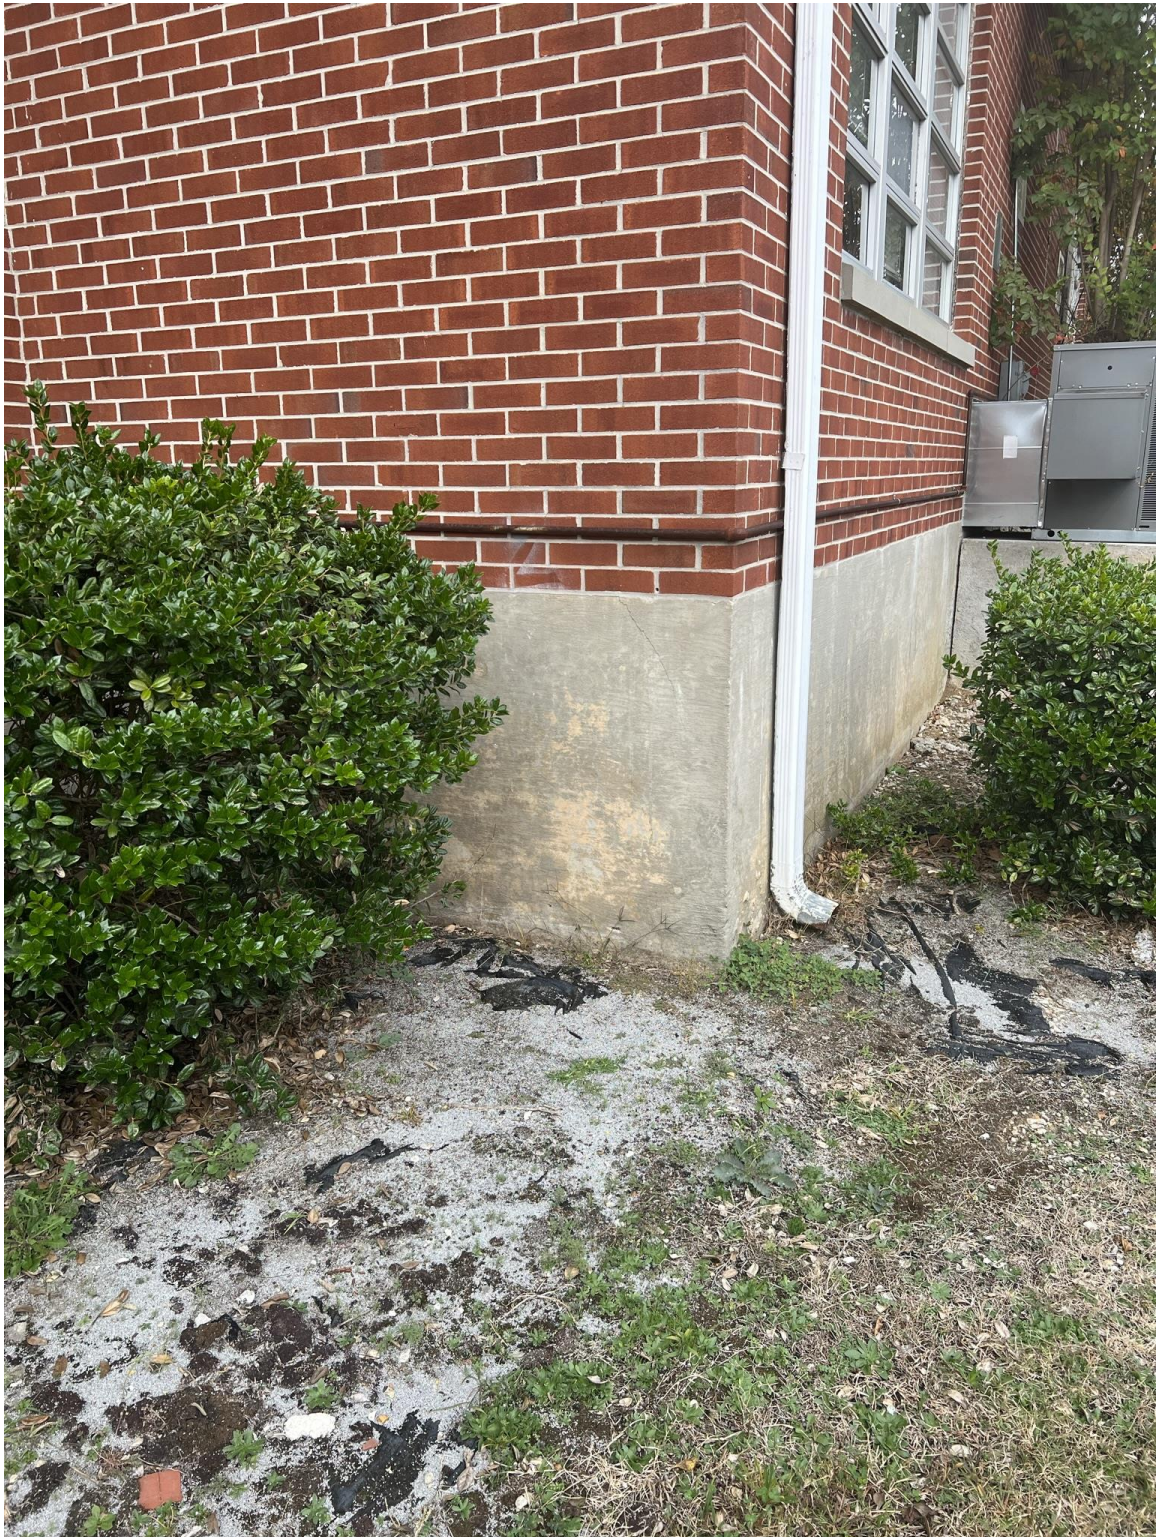
- 8) Large vegetation has been allowed to grow close to the buildings. It is recommended that this heavy vegetation be removed as the roots can damage the existing building footings. Also, the roof drainage downspouts are allowed to drain onto grade. This can also damage footings by allowing saturated soils and erosion at the building walls. These downspouts should be collected and carried underground away from the building.

Vegetation close to building and downspouts draining onto grade
