**COLBERT COUNTY
SCHOOLS**

Facility Assessment Report

Prepared by:
Volkert, Inc.

September 30, 2022

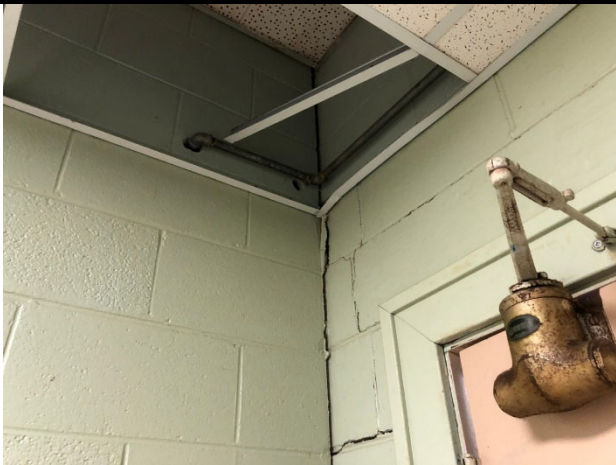
View of settlement at Auditorium.

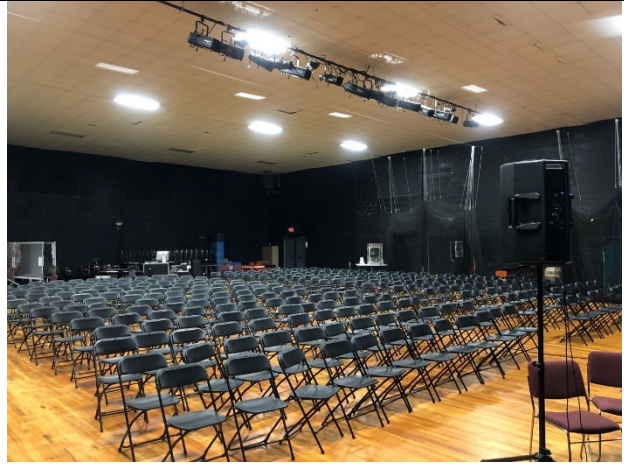
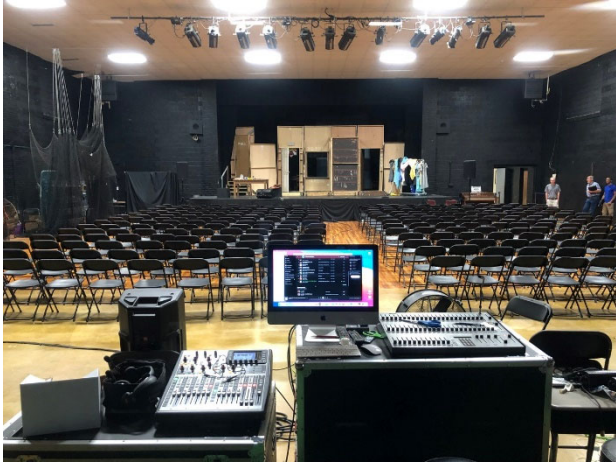
View of Auditorium.

Ceilings and lighting appeared to be in overall fair to poor condition. No ADA seating for spectators was observed and stage access is not ADA compliant. Apparent settlement has caused cracks in some walls with some lateral movement observed. However, this did not appear to be a Life/Safety concern. That said, review by a structural engineer is recommended. In addition, it appeared that this apparent settlement had also resulted in cracking of the brick veneer. Repair attempts have been made to address this cracking, but it is unknown whether or not they were successful. Damage to plaster walls and ceiling tiles is present, indicating that water infiltration of the building envelope has occurred at some time. It appears that a re-roof of this area has taken place. This re-roofing effort coupled with sealing of the brick veneer may have addressed the water infiltration. These areas should be observed periodically to verify that additional damage does not take place due to water infiltration.

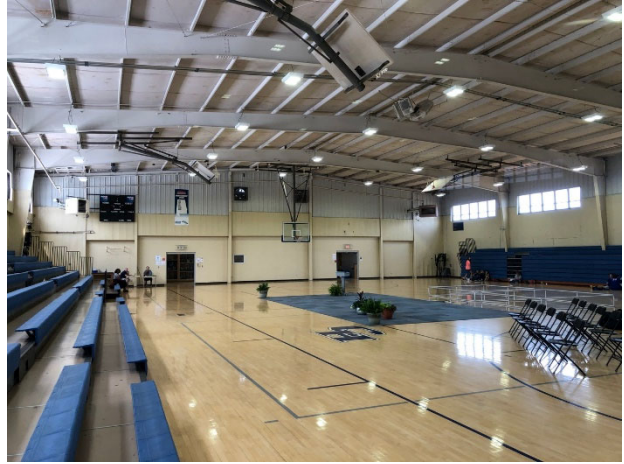
View of Gymnasium.

Athletic wood flooring in the gymnasium was observed to be in overall poor condition, with moisture damage present. Wood flush doors with hollow-metal frames were observed to be in overall fair condition. Door hardware appeared to be in overall poor condition. Concessions area has custom wood cabinets with a plastic laminate finish that appeared to be in overall fair to poor condition.

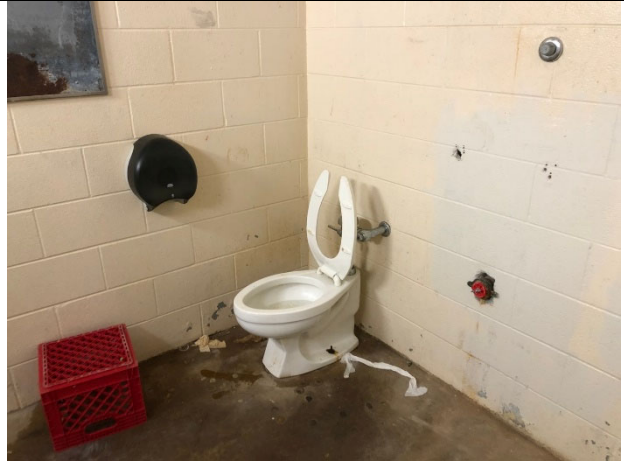
View of Locker Room Restroom.

Wood toilet partitions were observed to be in overall fair to poor condition, with no partitions present between urinals. Toilet accessories were observed to be in overall fair to poor condition, with missing accessories noted at select locations.

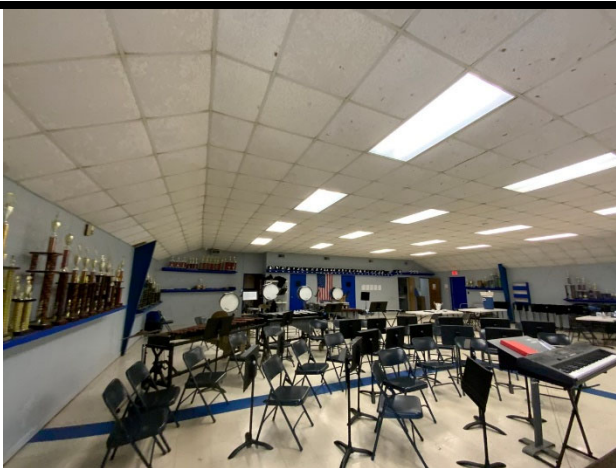
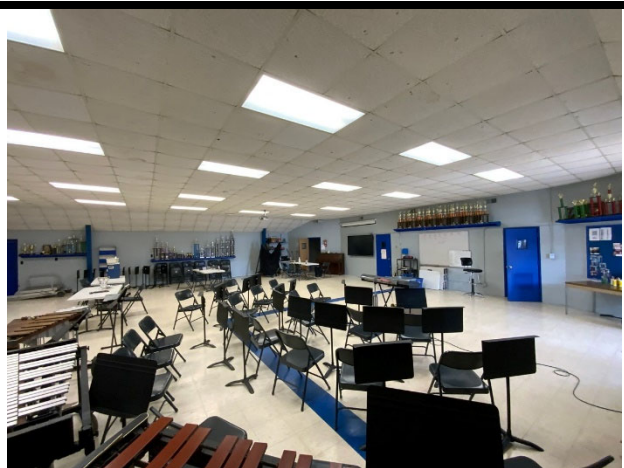
View of the Band Room.

Custom millwork with wood finish was observed for instrument storage and appeared to be in overall fair to poor condition. It was noted that no acoustical treatment was present on the ceilings or walls and that minimal instrument storage was present.
